TROUBLESHOOTING GUIDE

Sigma Agriculture

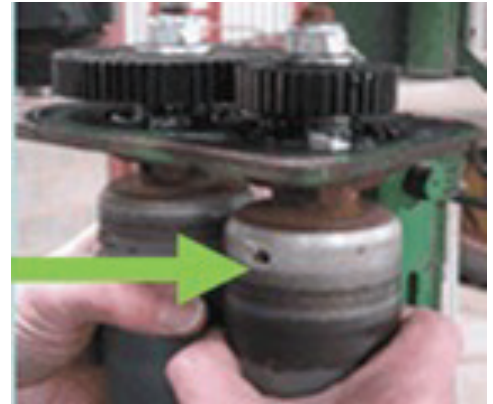
Roller Build Up

Issue: Over time, the tackifier used in silage film will rub on to the rollers of the machine causing the rollers to be covered in a sticky, black residue.

Solution: Clean rollers with white mineral spirit or automotive brake cleaner. Make sure that all build up has been removed from the rollers and retest.

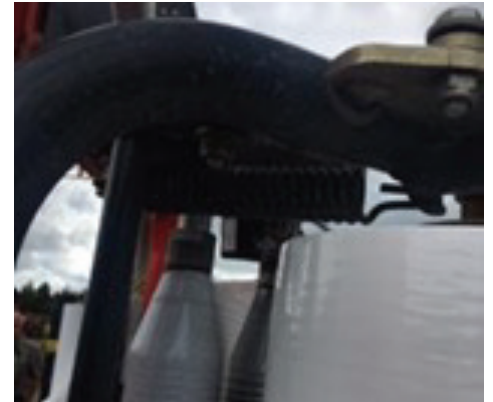
Are the springs in the pre-stretch unit weak?

Issue: The springs inside the pre-stretch unit will weaken or break over time. This can cause lack of tension on film during application.

Solution: Replace the weak springs in the pre-stretched unit to remove slack in the system.

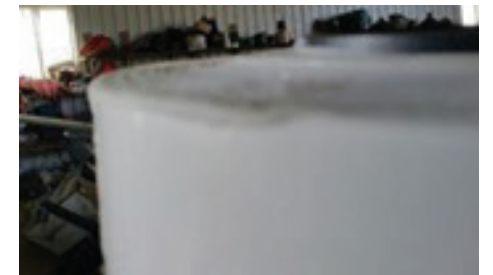
Is the edge damaged?

Issue: The roll was mishandled and has damaged. When rolls are dropped or damaged on the edge, the chance of film breaks increases dramatically.

Solution: Either pull the damaged film off the roll until undamaged film is exposed or replace the roll.

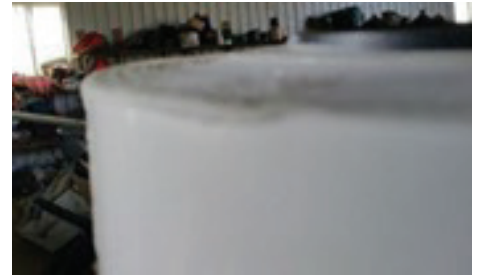
Is the edge damaged?

Issue: The roll was mishandled and has damaged. When rolls are dropped or damaged on the edge, the chance of film breaks increases dramatically.

Solution: Either pull the damaged film off the roll until undamaged film is exposed or replace the roll.

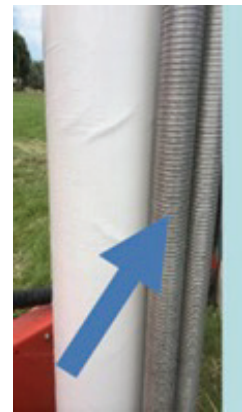
Are the rollers on the pre-stretch unit damaged?

Issue: When the rollers on the pre-stretch units are damaged (with nicks or cut for example), this can lead to tearing of the film during wrapping.

Solution: Replace the rollers or attempt to fix the damage and try again. Additionally, clear the rollers of any debris.

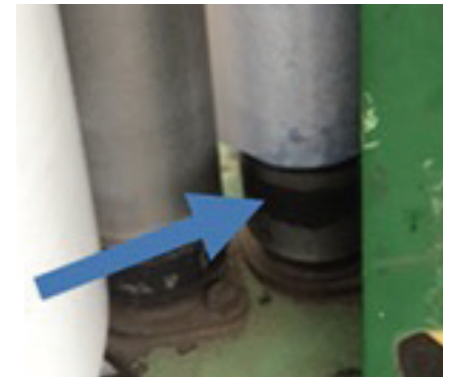
Issue: Over time the tackifier used in silage film will rub on to the rollers of the machine causing the rollers to be covered in a sticky, black residue.

Solution: Clean rollers with white mineral spirit or automotive brake cleaner. Make sure that all build up has been removed from the rollers and retest.

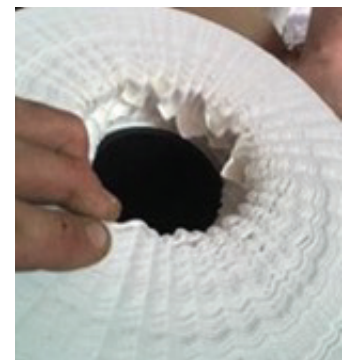
Winding Fault

Issue: Some of the ingredients used in the film can cause layers to slide between each other.

Solution: Unwind the film until any flaws have been removed. Try the roll again after unwinding. If the film is still unusable, please email us for technical assistance.

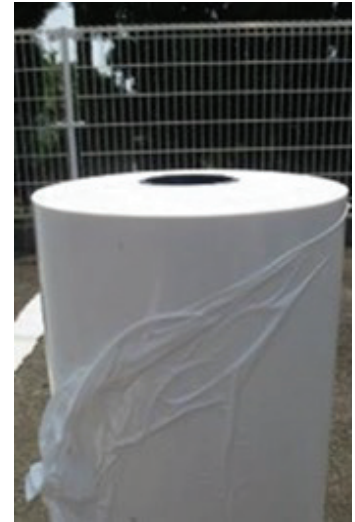
Core Misalignment

Issue: One side of the roll is flush with the core, making it impossible for film to properly cycle through the wrapper.

Solution: If the rolls in this condition, and was stored properly, please send us a detailed email (with supporting pictures) describing your issue. Sigma will get back to you within 5 business days with the Technical Support. In you detailed email, be sure to include your contact information, any photos you may have, the core number, and the roll number of the film, as well as any additional notes or comments.

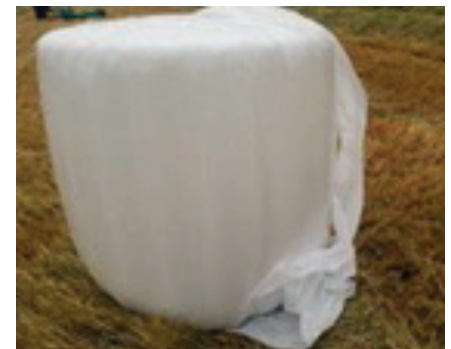
Insufficient Coverage

Issue: All Bales must be covered with at least 6 layers of film at all points. Fewer layers make the bale subject to spoilage, therefore more wraps is always recommended.

Solution: Apply enough film so that all areas of bale have at least 6 layers of film.

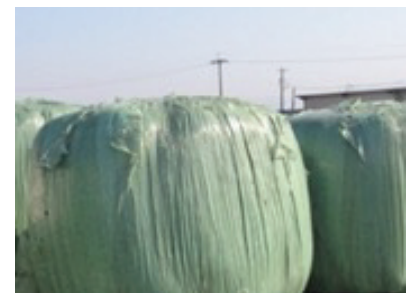
UV Degradation

Issue: Ultraviolet light, oxygen, and heat all will degrade polyolefins and cause brittleness, color change, and product failure. However, there are additives called Ultraviolet Inhibitors that trap the free radicals which form during the photo-oxidation process, retarding the breakdown of the film. However, over time, the sun degrades the UV Inhibitors in the plastic.

Solution: The plastic is guaranteed for a period of 12 month from the date of proper application and use. If the film is showing signs of degradation within this warranty period, please contact technical support. Please be sure to include a detailed description of your issue, your contact information any photos you have, the core number and roll number of the film.

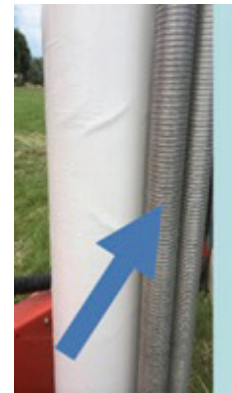
Roller Damage

Issue: When the rollers on the pre-stretch units are damaged, with nicks or cuts for example, this can lead to tearing of the film during wrapping.

Solution: Replace the rollers or attempt to fix the damage and try again. Additionally, clear the rollers of all other debris.

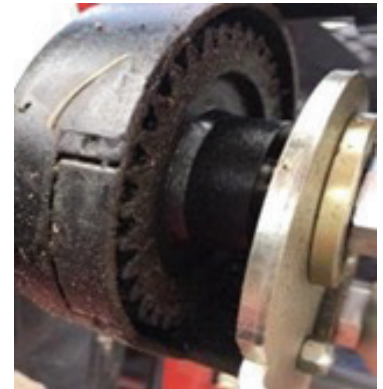
Worn Gears

Issue: Gears that have worn or been damaged can cause rollers to bind, which creates additional tension.

Solution: If the pre-stretch unit gears are worn or binding, they must be replaced. This ensures the film stretches properly without excessive resistance.

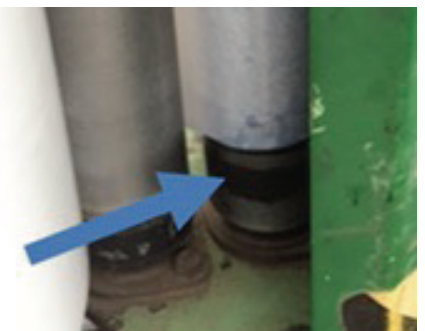
Build up on pre-stretch unit

Issue: Over time, the tackifier used in silage film will rub on to the rollers causing them to be covered in a sticky residue.

Solution: Clean rollers with white mineral spirit or automotive brake cleaner. Make sure all build up has been removed from the rollers and retest.

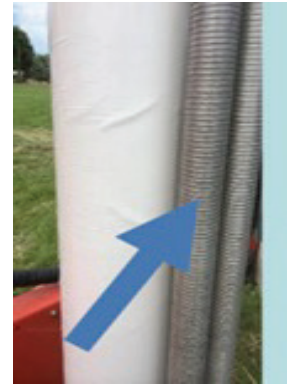
Poor Wrapping Conditions

Issue: The film's adhesion efficiency is reduced when it comes into contact with rain, dust, dirt, or debris.

Solution: Remove any dirt from the film where possible and let dry as needed. Remember to wrap bales in optimal weather conditions.
