TROUBLESHOOTING GUIDE

Sigma Agriculture

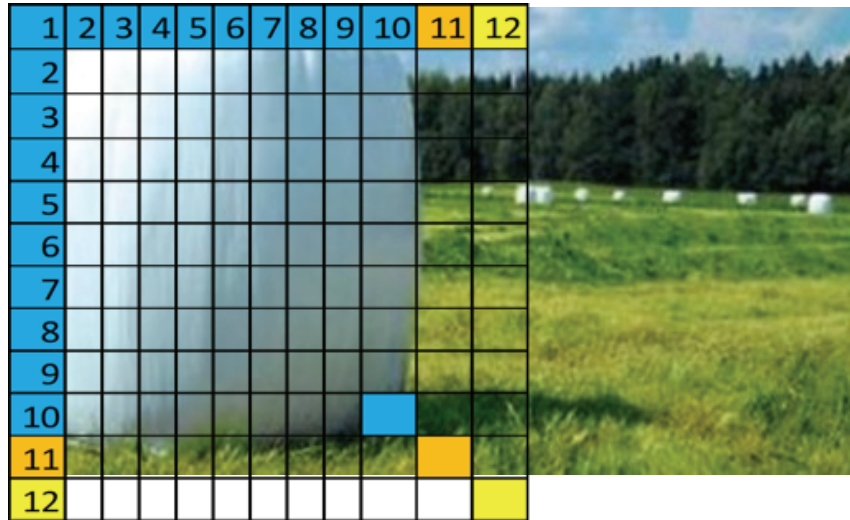
Overstretching

- If the material is overstretch by ONLY 10%, material surface increases by 21%.
- This would reduce tack level by 21%.
- If the material is overstretch by 20% (12x12= 144) tack level would decrease by 44%.
 - This would give you the impression that the material has no tack while wrapping.

10 x 10 = 100	Excellent Coverage and Tack Levels
11 x 11 = 121	Increase Surface Coverage and Decrease Tack Levels by 21%
12 x 12 = 144	Increase Surface Coverage and Decrease Tack Levels by 44%

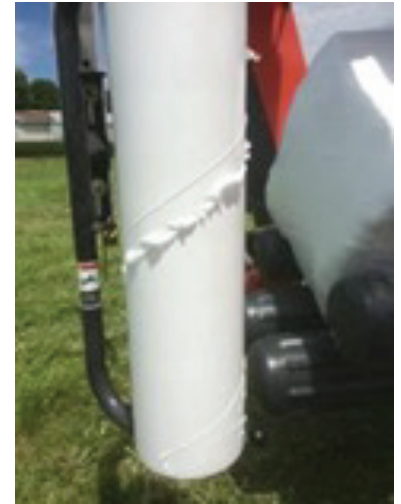
Is there any build up on the pre-stretch unit rollers?
